# Manhole Inspection Summary

Manhole # S15E1\_011MH

Insp Date: **5/7/09 12:44 PM**

**Location** Address: **1701 PARKMAN AV**

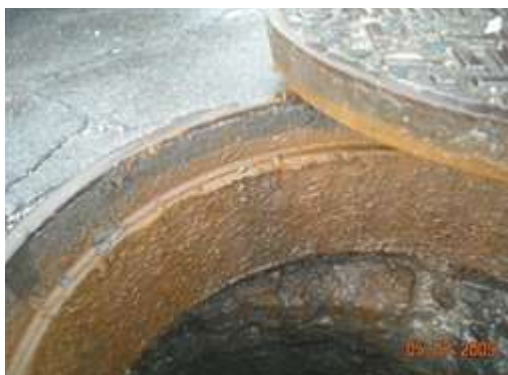
Defect 6

☒ **Leaks**

FRAME LEAKS

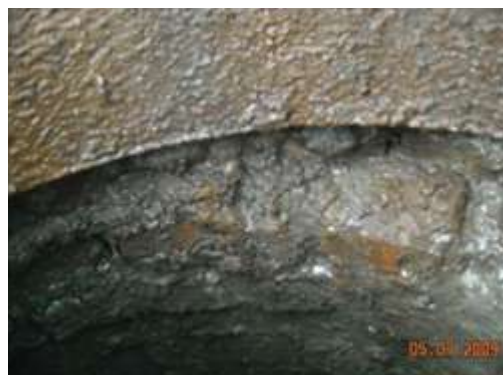
Defect 4

Condition: ☐ Sound ☐ Cracked ☐ Root Intrusion ☐ Loose Brick ☒ **Deteriorated**

Infiltration: ☐ None ☒ **Joint** ☐ Cracks ☐ Mortar ☐ Roots ☐ Wall

DETERIORATED CHIMNEY;  
INFILTRATION FROM JOINT

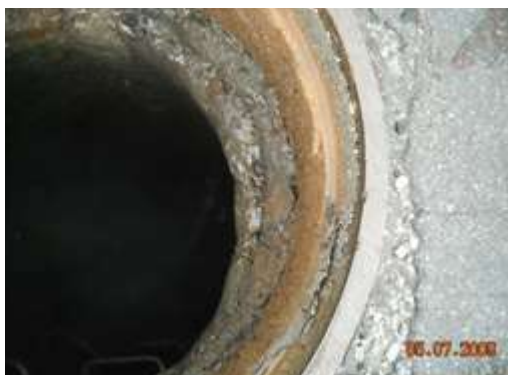
Defect 3

Offset: **3** (in.)

FRAME OFFSET

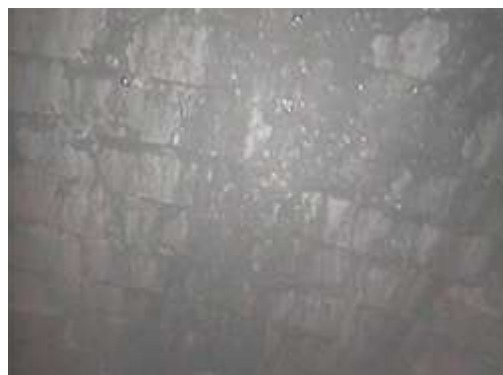
Defect 2

Infiltration: ☐ None ☐ Joint ☐ Cracks ☐ Mortar ☐ Roots ☒ **Wall**

INFILTRATION @ CORBEL WALL

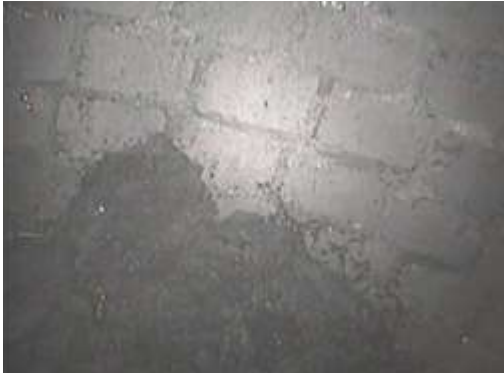
### Defect 1

Condition: ☐ Sound ☐ Cracked ☐ Root Intrusion ☐ Deteriorated ☐ Leaks ☒ **Debris**

DEBRIS ON BENCH

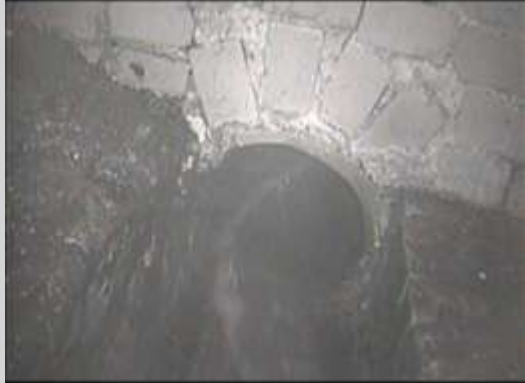
12 O'Clock Outflow

Pipe Height: **8.4** (in.) Rod and Bar (Angled)  
Pipe Material: **Clay** ☐ Pipe Lined  
Invert Depth: **12.57** (ft.) Flow Characteristics: **Slow**  
Deposits: ☒ None ☐ Mud ☐ Sludge ☐ Debris ☐ Grease  
Silt Depth: **0** (in.) Deposits Extent:  
Infiltration: **None** Pipe Seal Cond: **Sound**

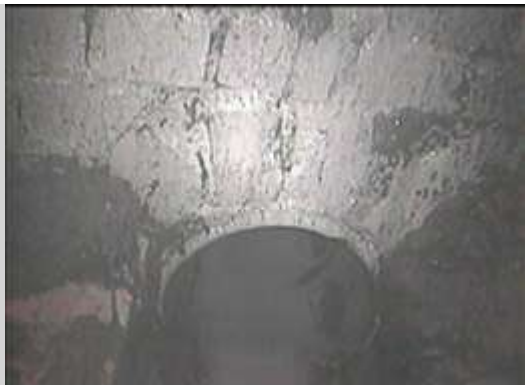
3 O'Clock Inflow

Pipe Height: **8.4** (in.) Rod and Bar (Angled)  
Pipe Material: **Clay** ☐ Pipe Lined  
Invert Depth: **12.10** (ft.) Flow Characteristics: **Slow**  
Deposits: ☒ None ☐ Mud ☐ Sludge ☐ Debris ☐ Grease  
Silt Depth: **0** (in.) Deposits Extent:  
Infiltration: **None** Pipe Seal Cond: **Sound**

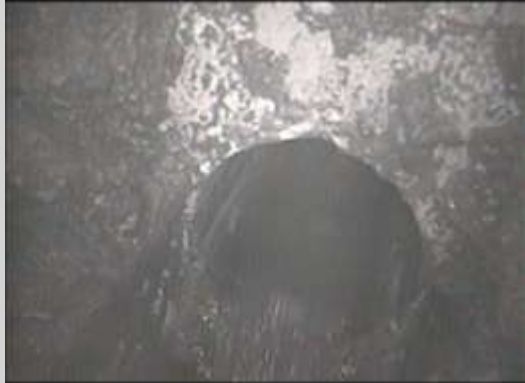
6 O'Clock Inflow

Infiltration: **None** Pipe Seal Cond: **Unknown**
